Manhole Inspection Summary

Manhole # S15SS_014MH

Location Address: **3000 LIBERTY HEIGHTS**

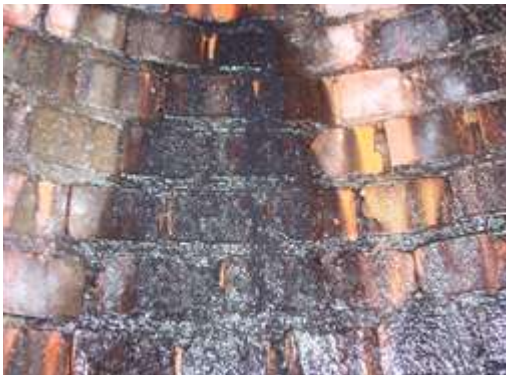
Defect 1

Infiltration: ☐ None ☐ Joint ☐ Cracks ☐ Mortar ☐ Roots ☒ **Wall**

INFILTRATION WEEPER- BARREL

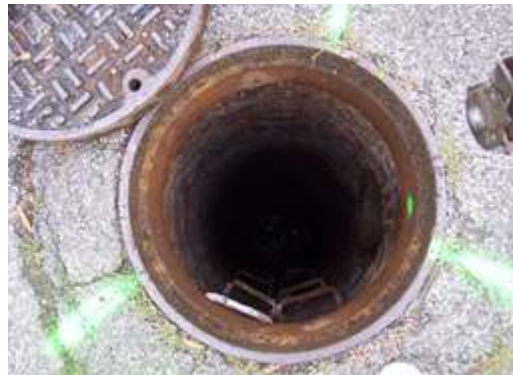
Defect 2

Count: **14** Missing: **0** ☒ **Corroded**

CORRODED STEPS

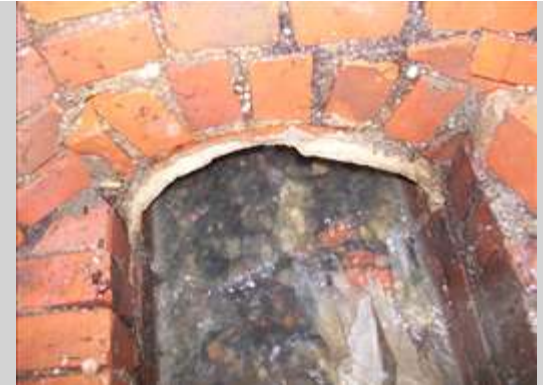
12 O'Clock Outflow

Pipe Height: (in.) Direct
Pipe Material: **Clay** ☐ Pipe Lined
Invert Depth: **26.38** (ft.) Flow Characteristics: **Fast**
Deposits: ☐ None ☐ Mud ☐ Sludge ☒ **Debris** ☐ Grease
Silt Depth: **2** (in.) Deposits Extent: **Medium**
Infiltration: **None** Pipe Seal Cond: **Sound**

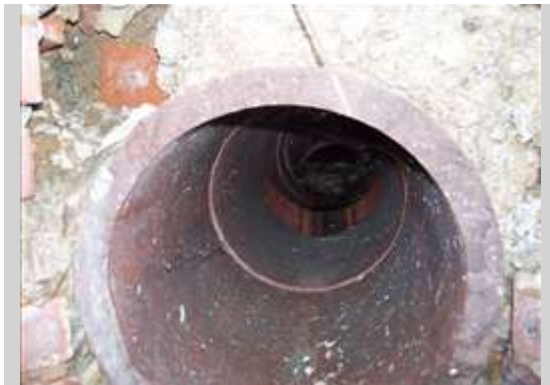
3 O'Clock Inflow

Pipe Height: (in.) Direct
Pipe Material: **Clay** ☐ Pipe Lined
Invert Depth: **6.59** (ft.) Flow Characteristics: **Slow**
Deposits: ☒ None ☐ Mud ☐ Sludge ☐ **Debris** ☐ Grease
Silt Depth: (in.) Deposits Extent:
Infiltration: **None** Pipe Seal Cond: **Sound**

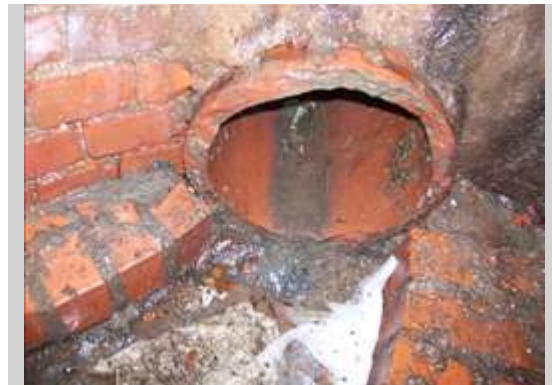
Drop In @ 3 O'Clock

Drop: **Outside Direct**
Angled: Reading: (ft.)
Inv Depth: **25.51** (ft.)
Drop Condition: **Open**

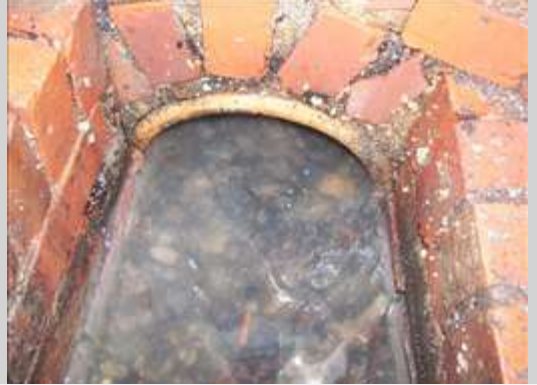
7 O'Clock Inflow

Deposits: ☐ None ☐ Mud ☐ Sludge ☒ **Debris** ☐ Grease

Silt Depth: **2** (in.) Deposits Extent: **Medium**
